# *Environmental Effects of Dredging Technical Notes*

## EQUIPMENT MOBILITY IN CONFINED DREDGED MATERIAL DISPOSAL AREAS; FIELD EVALUATIONS

**PURPOSE:** This technical note describes recently completed equipment evaluations and presents data on mobility of this equipment in confined dredged material containment areas. The equipment evaluation included newly developed four- and six-wheeled low-ground-pressure vehicles. This equipment is typically used to tow a rotary ditching device to create surface trenches to enhance drainage and dewatering of confined dredged material disposal sites.

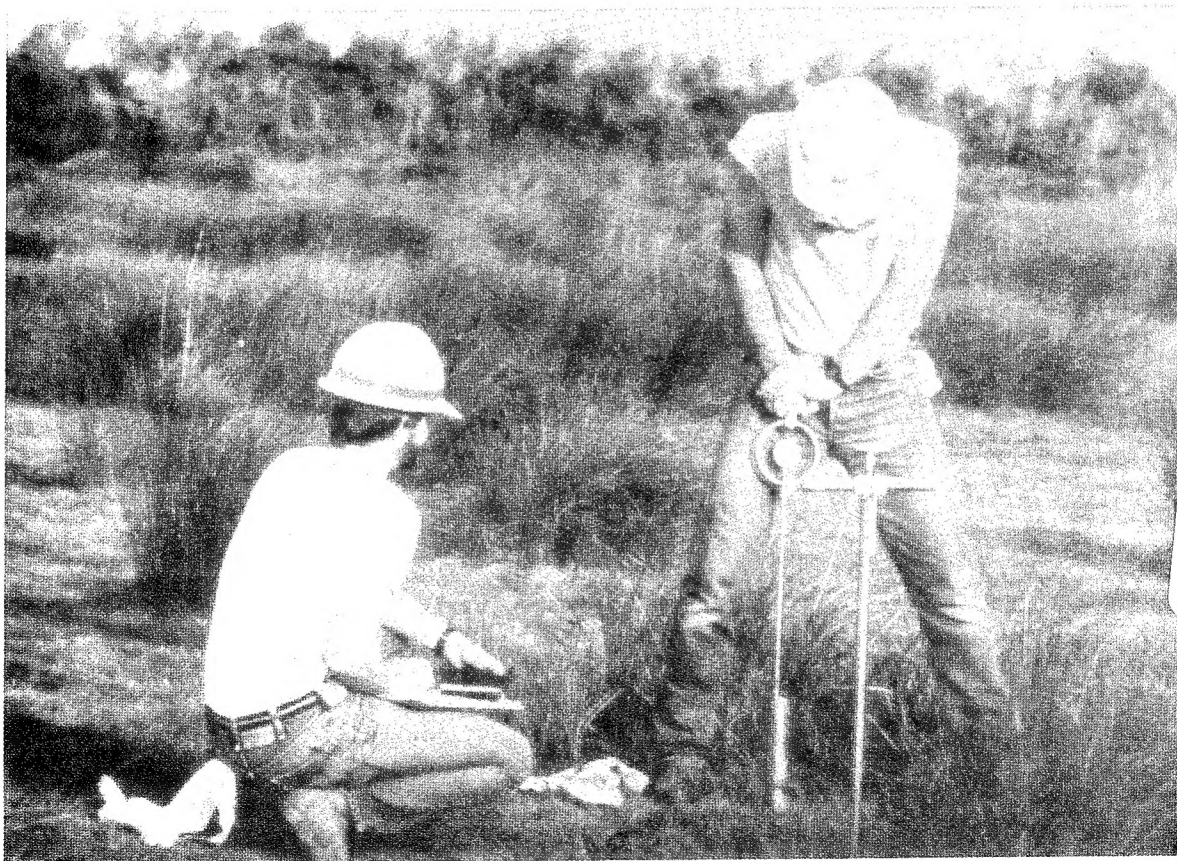
Figure 1. Field soil testing for vehicle mobility determination using the cone penetrometer

During field evaluations, data on the equipment, the equipment operation and performance, and the soils were collected. Pertinent data on the equipment included weight, horsepower, number of tires, and vehicle ground contact pressure. Operation and performance data included speed of movement across the disposal site, linear feet of ditching accomplished per hour, and size of the trench formed (which indicates rate of production in quantity of material removed per hour). Soils data collected included soil strength as recorded by the hand-held cone penetrometer, shown in operation in Figure 1. Results of the field evaluations are discussed in following sections.

To evaluate the potential for equipment mobility in a dredged material disposal site, field data on soil strength must be collected. These data included the cone index (CI) and remolding index (RI), from which the rating

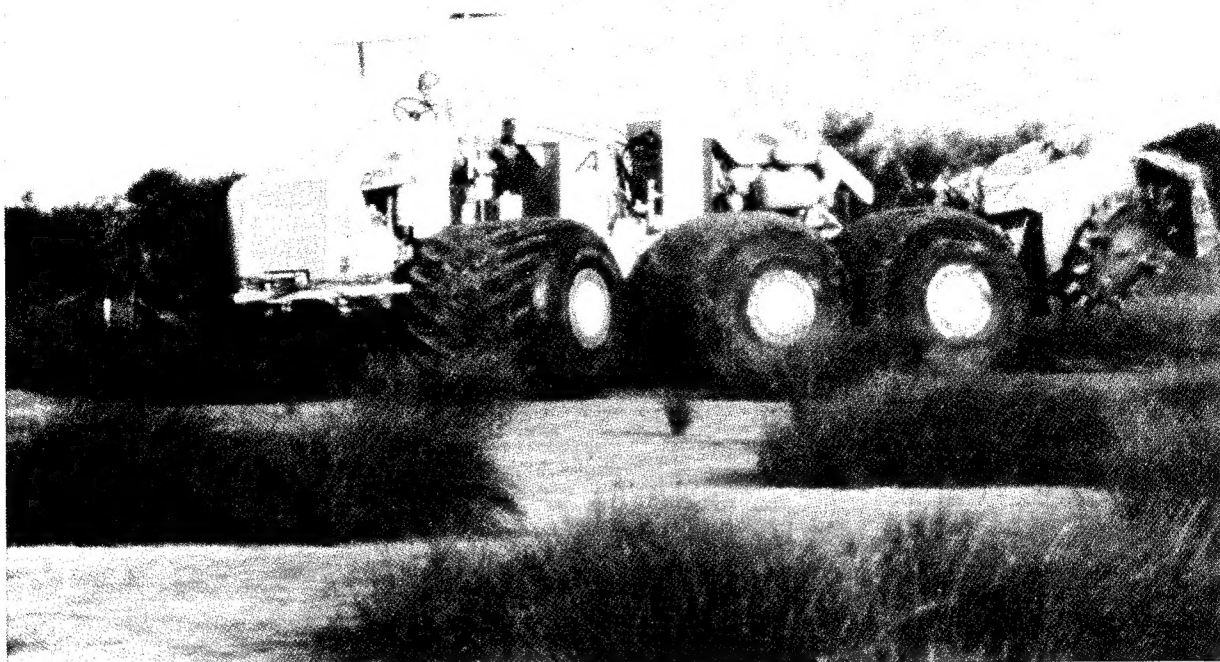
Figure 3. Rubber-tired ARDCO vehicle with Dondi ditcher raised between trenching operations in Triple Barrel disposal site

The equipment tested at Triple Barrel was an ARDCO "K" 6x6 rubber-tired vehicle which pulled a Dondi 95 ditcher (shown operating in Figure 3). The equipment is owned and operated by ARDCO of Houston, TX. The ARDCO has 113 hp and weighs 22,100 lb; it has a vehicle ground contact pressure of 1/64 psi. A tracked marsh buggy was kept on standby at the disposal site to pull the ARDCO

vehicle through soft sections, if necessary. The vehicle cone index (VCI) of this vehicle was determined to be 7 for reconnaissance (one pass of the equipment); the  $VCI_{50}$  for multiple passes over the same area was 18.

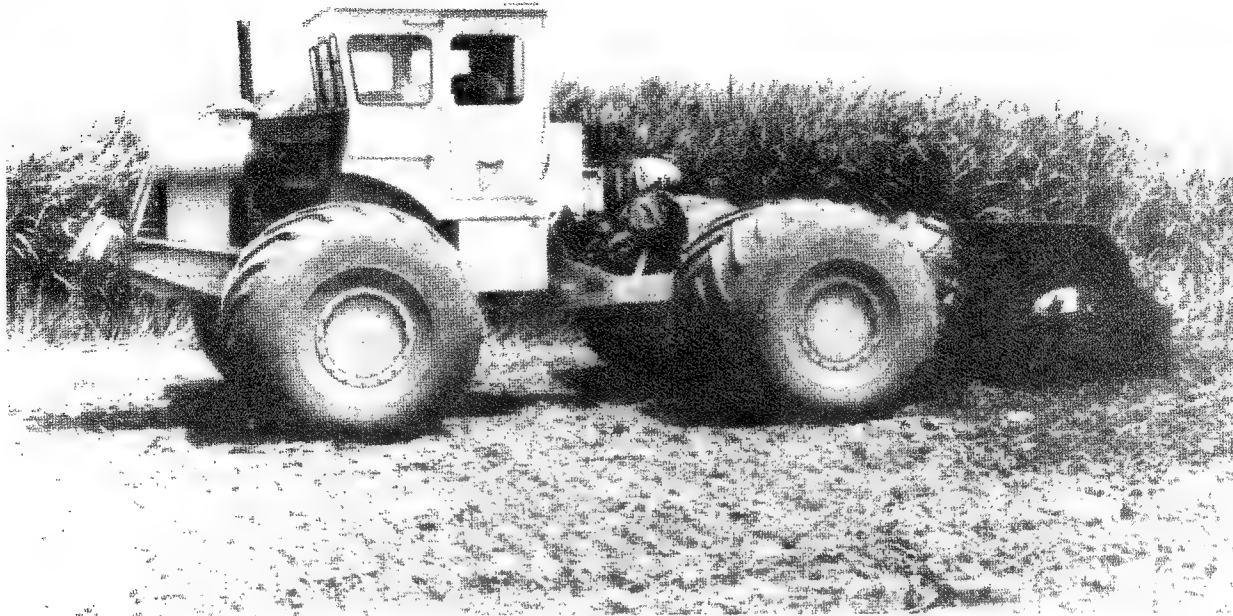
Figure 7. GEMCO vehicle with Dondi ditcher being lowered into position for trenching

The Artificial Island disposal area was the location of field equipment evaluations on June 15-17, 1987. The disposal site, located approximately 60 miles southwest of Philadelphia, is compartmentalized into three separate cells by interior dikes. Figure 6 is a map of the Artificial Island site. Each cell has one weir for water drainage. The dredged material in Artificial Island is predominantly sandy clay. No specific information was available on the thickness of the dredged material deposit in this site. All three cells were covered with a thick growth of *Phragmites* which had to be removed by bulldozing before trenching could begin to prevent entanglement of the vegetation in the rotary ditching device (Figure 7).

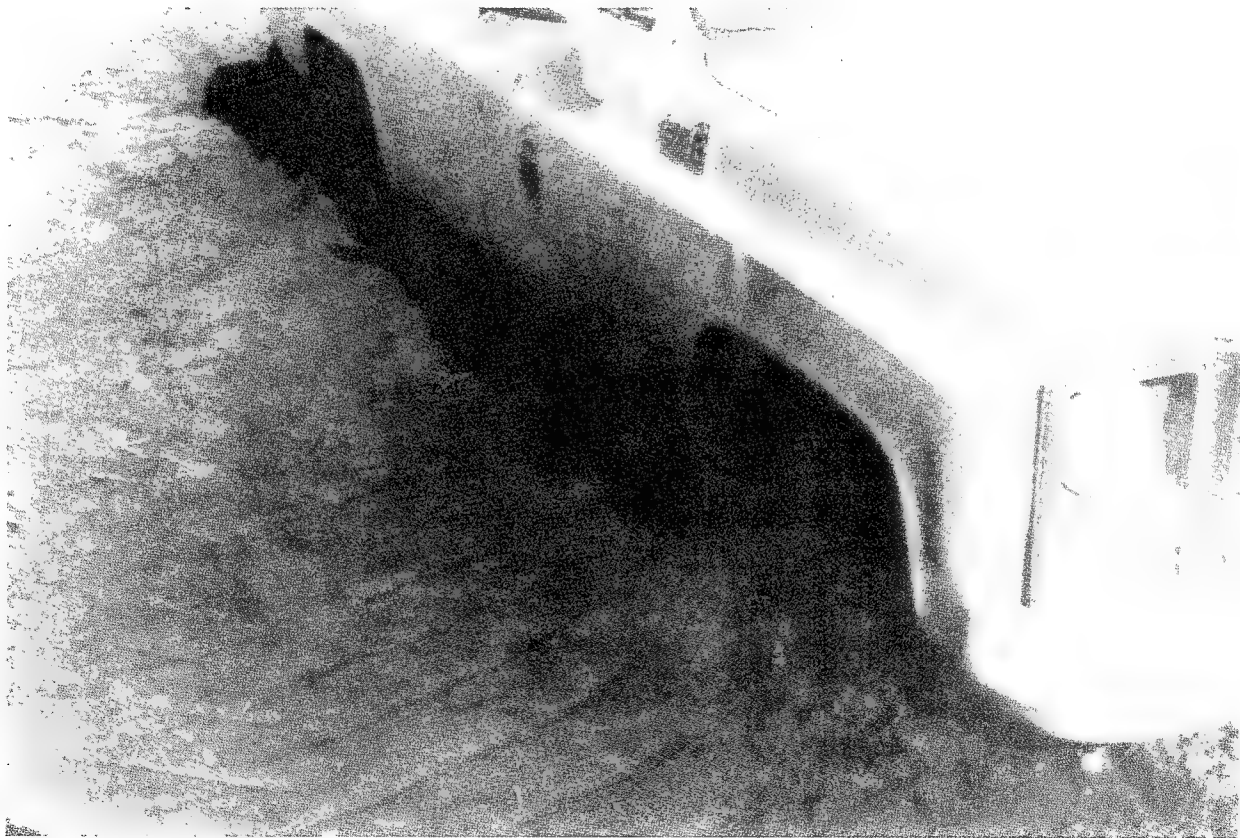
Figure 10. Corps of Engineers 4x4 vehicle immobilized where GEMCO pulling ditcher had no problem; note GEMCO treadmarks beside vehicle

All vehicles evaluated in this study were able to perform successfully when adequate crust was present, but none were mobile during the entire critical period between fluid and solid phases of dredged material. These rubber-tired, low-ground-pressure vehicles were able to operate at the dredged material disposal sites earlier than most conventional equipment (Figure 10). It should be noted that some low-ground-pressure tracked vehicles were not only mobile in the areas where the rubber-tired vehicles had mobility problems, but were used to tow immobilized equipment. The greatest problem with immobilization of either the ARDCO or the GEMCO seems to occur when the vehicle breaks

through the hardened crust and the soft material below cakes between the tire treads causing a loss of traction.
